HISTORIC AMERICAN BUILDINGS SURVEY
INVENTORY

2. NAME *Orrin Thompson Mansion*

DATE OR PERIOD *1832*
STYLE *Greek Revival*
ARCHITECT
BUILDER *Orrin Thompson*

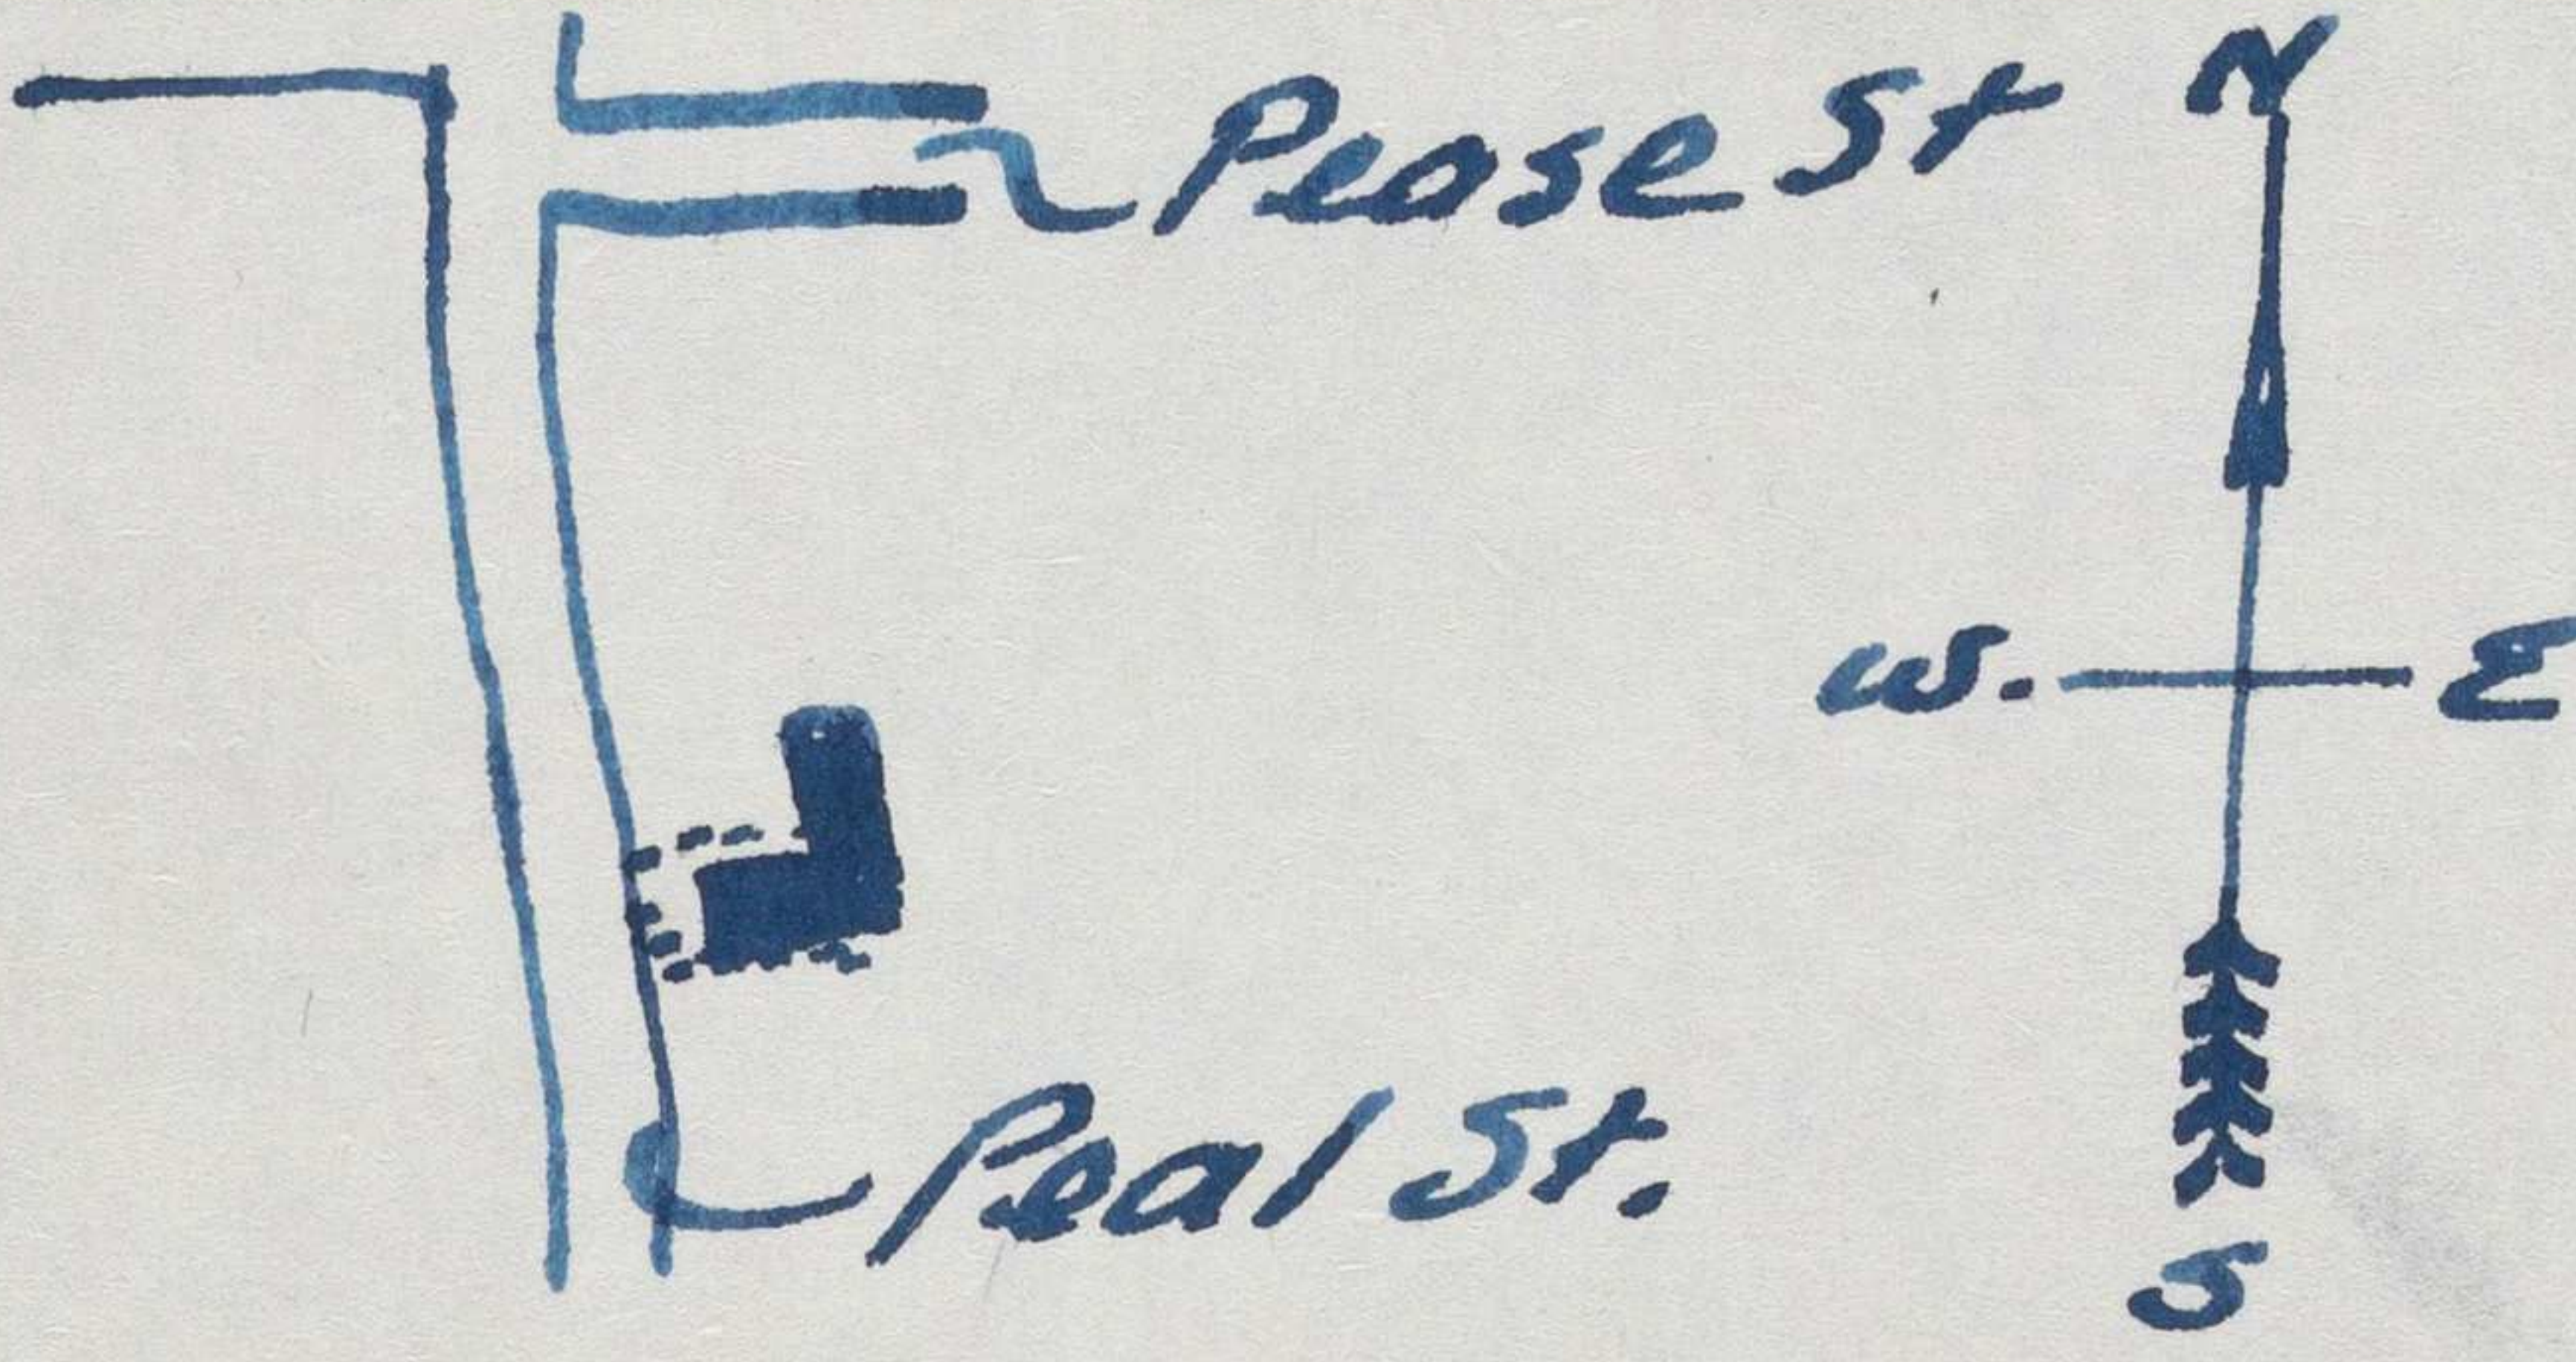
<p>7. PHOTOGRAPH <i>Enf 136</i></p>
<p>8. PUBLISHED SOURCES (Author, Title, Pages) INTERVIEWS, RECORDS, PHOTOS, ETC.</p>	<p>9. NAME, ADDRESS AND TITLE OF RECORDER <i>Elric J. Endersby</i> <i>Elric J. Endersby</i> DATE OF RECORD <i>7/19/67</i></p>

<p>1. STATE <i>CT</i> COUNTY TOWN <i>Enfield</i> VICINITY STREET NO. <i>129-131 Pearl St.</i> ORIGINAL OWNER ? ORIGINAL USE <i>Residence</i> PRESENT OWNER <i>Masons</i> PRESENT USE <i>Masonic Temple</i> WALL CONSTRUCTION <i>clapboard</i> NO. OF STORIES <i>2</i></p>	<p>HISTORIC AMERICAN BUILDINGS SURVEY INVENTORY</p> <p>2. NAME <i>Masonic temple</i> DATE OR PERIOD <i>1880</i> STYLE <i>Mansard.</i> ARCHITECT BUILDER</p> <p>3. FOR LIBRARY OF CONGRESS USE</p>
<p>4. NOTABLE FEATURES, HISTORICAL SIGNIFICANCE AND DESCRIPTION OPEN TO PUBLIC <i>No.</i></p> <p><i>This fine mansard roofed house is built upon a brick foundation. The main section is in three bays on the 2nd and dormer levels, but only 2 on the first due to the indentation on both sides to allow a wider porch. The windows are the 2 1/2's extending to floor level on the first floor, all being segmental topped. The dormers in the decorated slate roof are of two types the first and third bay dormers being flat topped, the cented having two arched heads. The cornice is bracketed and dentilled. To the north is a one story mansard roofed ell masked behind a colored glass solarium.</i></p> <p>5. PHYSICAL CONDITION OF STRUCTURE Endangered <i>No</i> Interior <i>fair?</i> Exterior <i>fair</i></p>

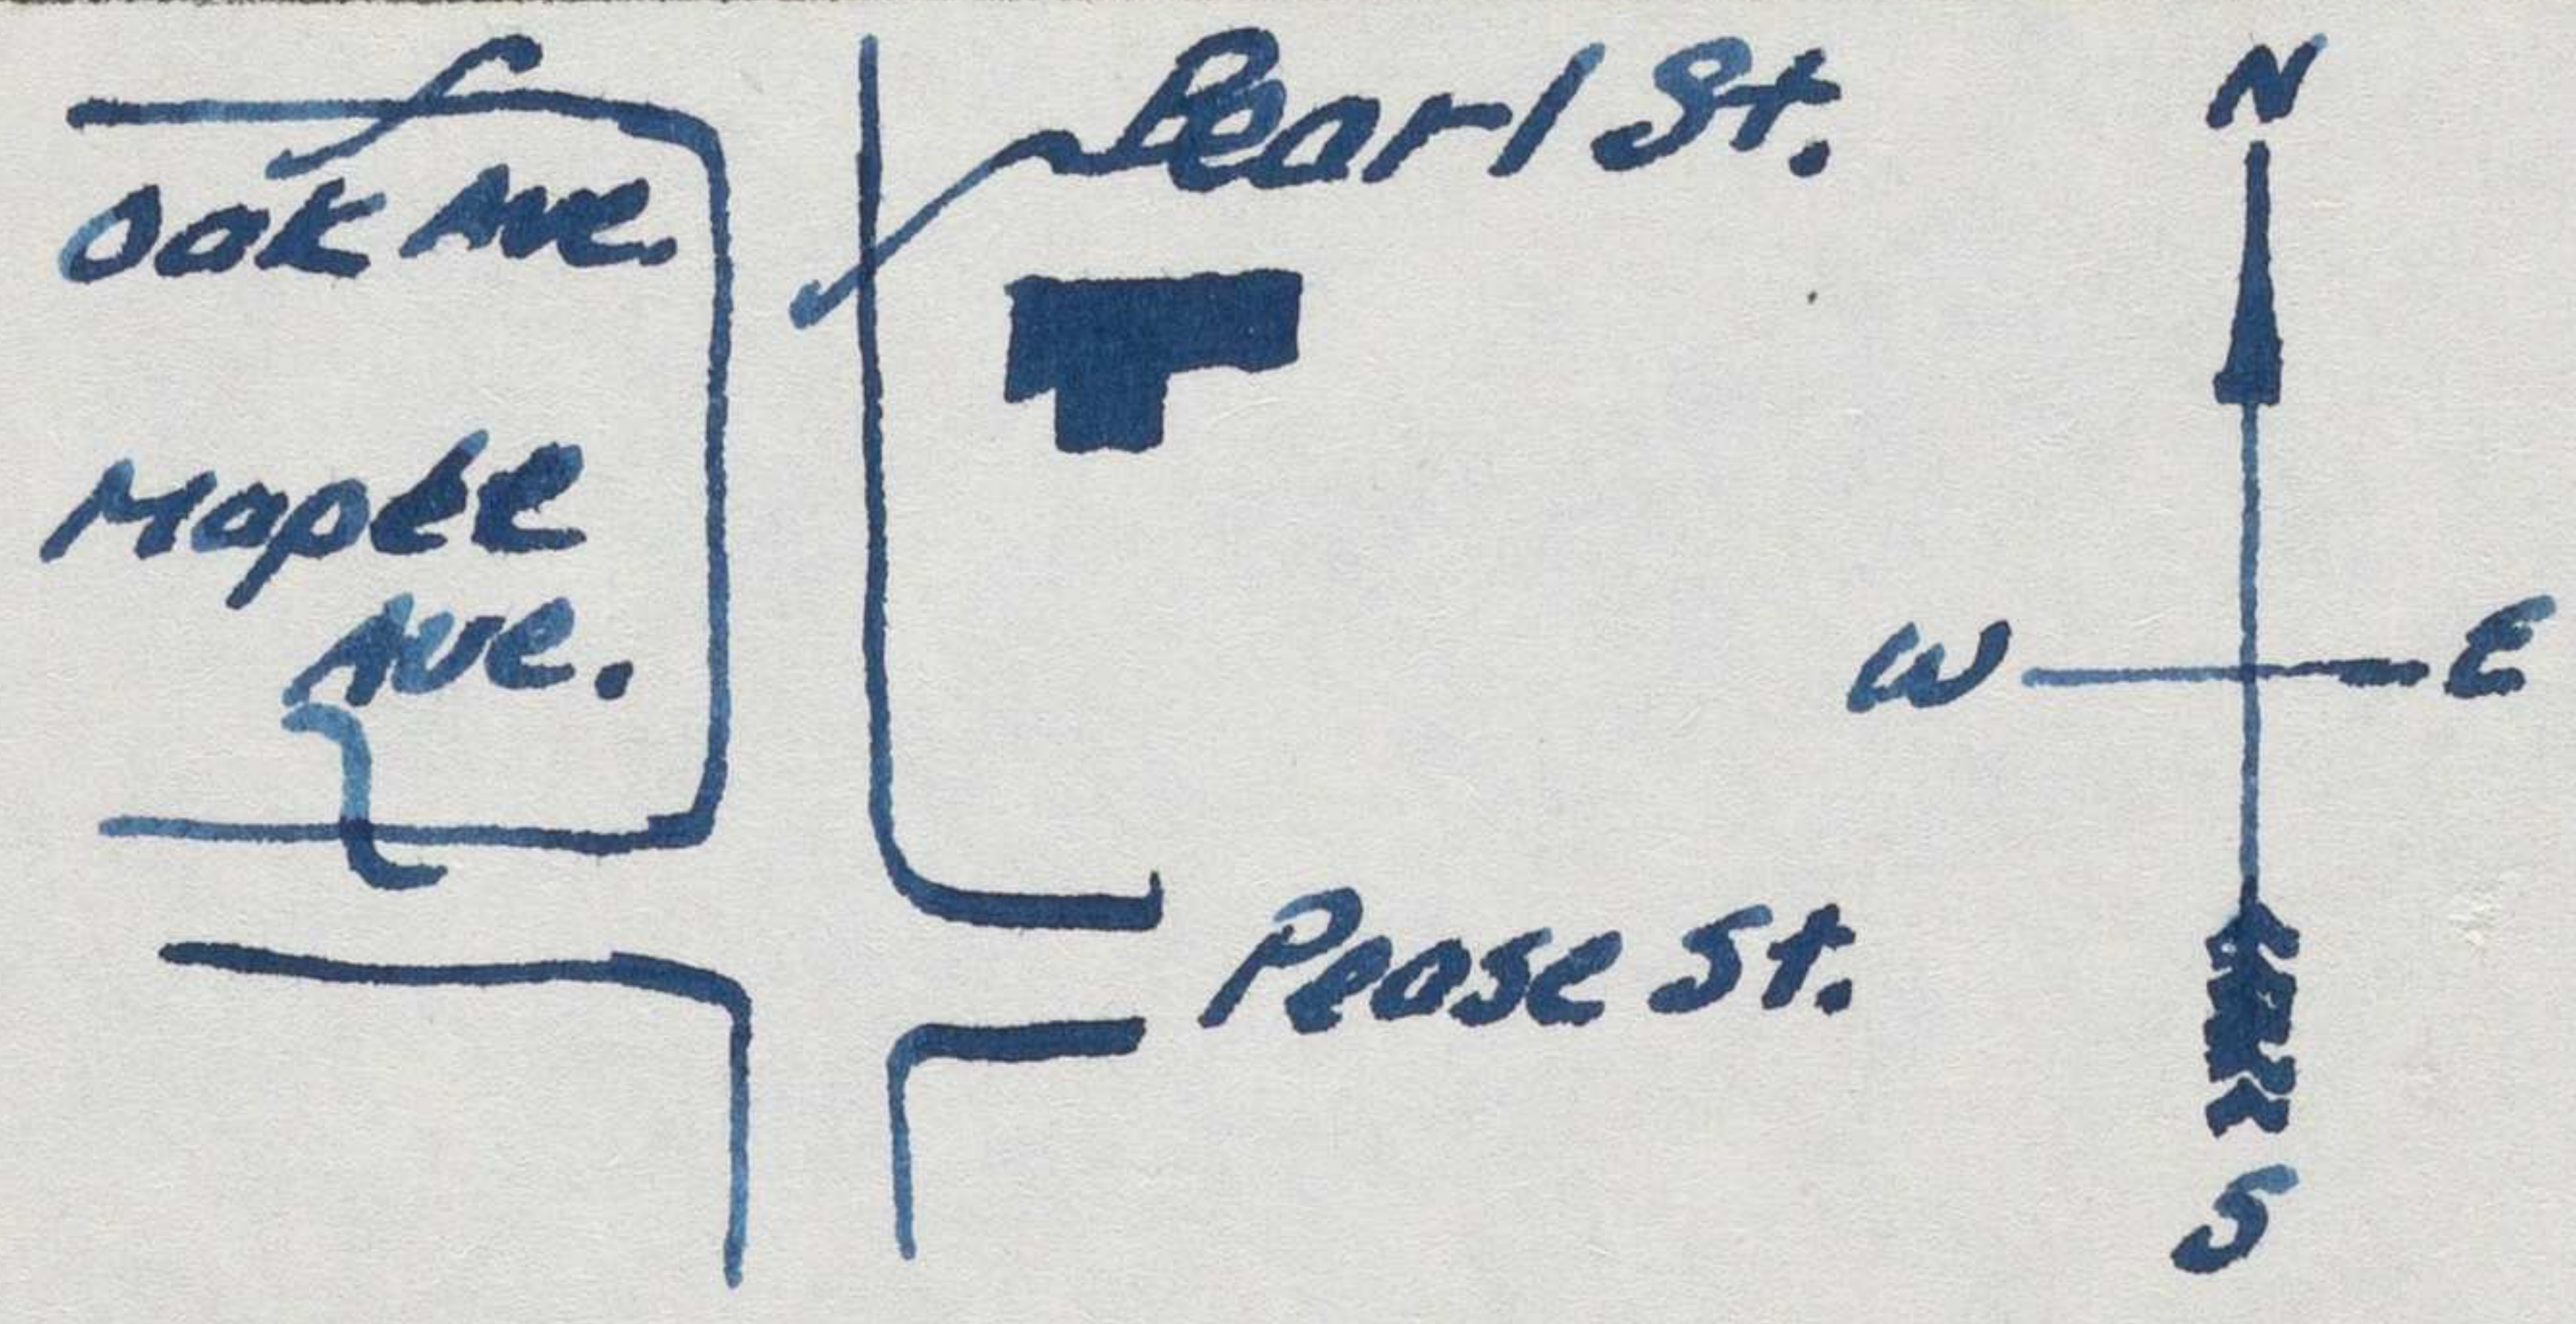
6. LOCATION MAP (Plan Optional)	7. PHOTOGRAPH <i>Enf 137</i>
---------------------------------	------------------------------

This is an example of Eclecticism at its frivolous best. Built on a brownstone foundation the house is of brick, ornamented with brownstone dressings and panels of checkerboard patterns of painted terra cotta. The windows are so differently placed that the photograph will tell better there curiosities than I might. The slate roof forms heavy projecting gables in all directions. A porch to the S.W. fulfills the design.

5. PHYSICAL CONDITION OF STRUCTURE	Endangered <i>No</i> Interior <i>fair?</i> Exterior <i>fair</i>
------------------------------------	---

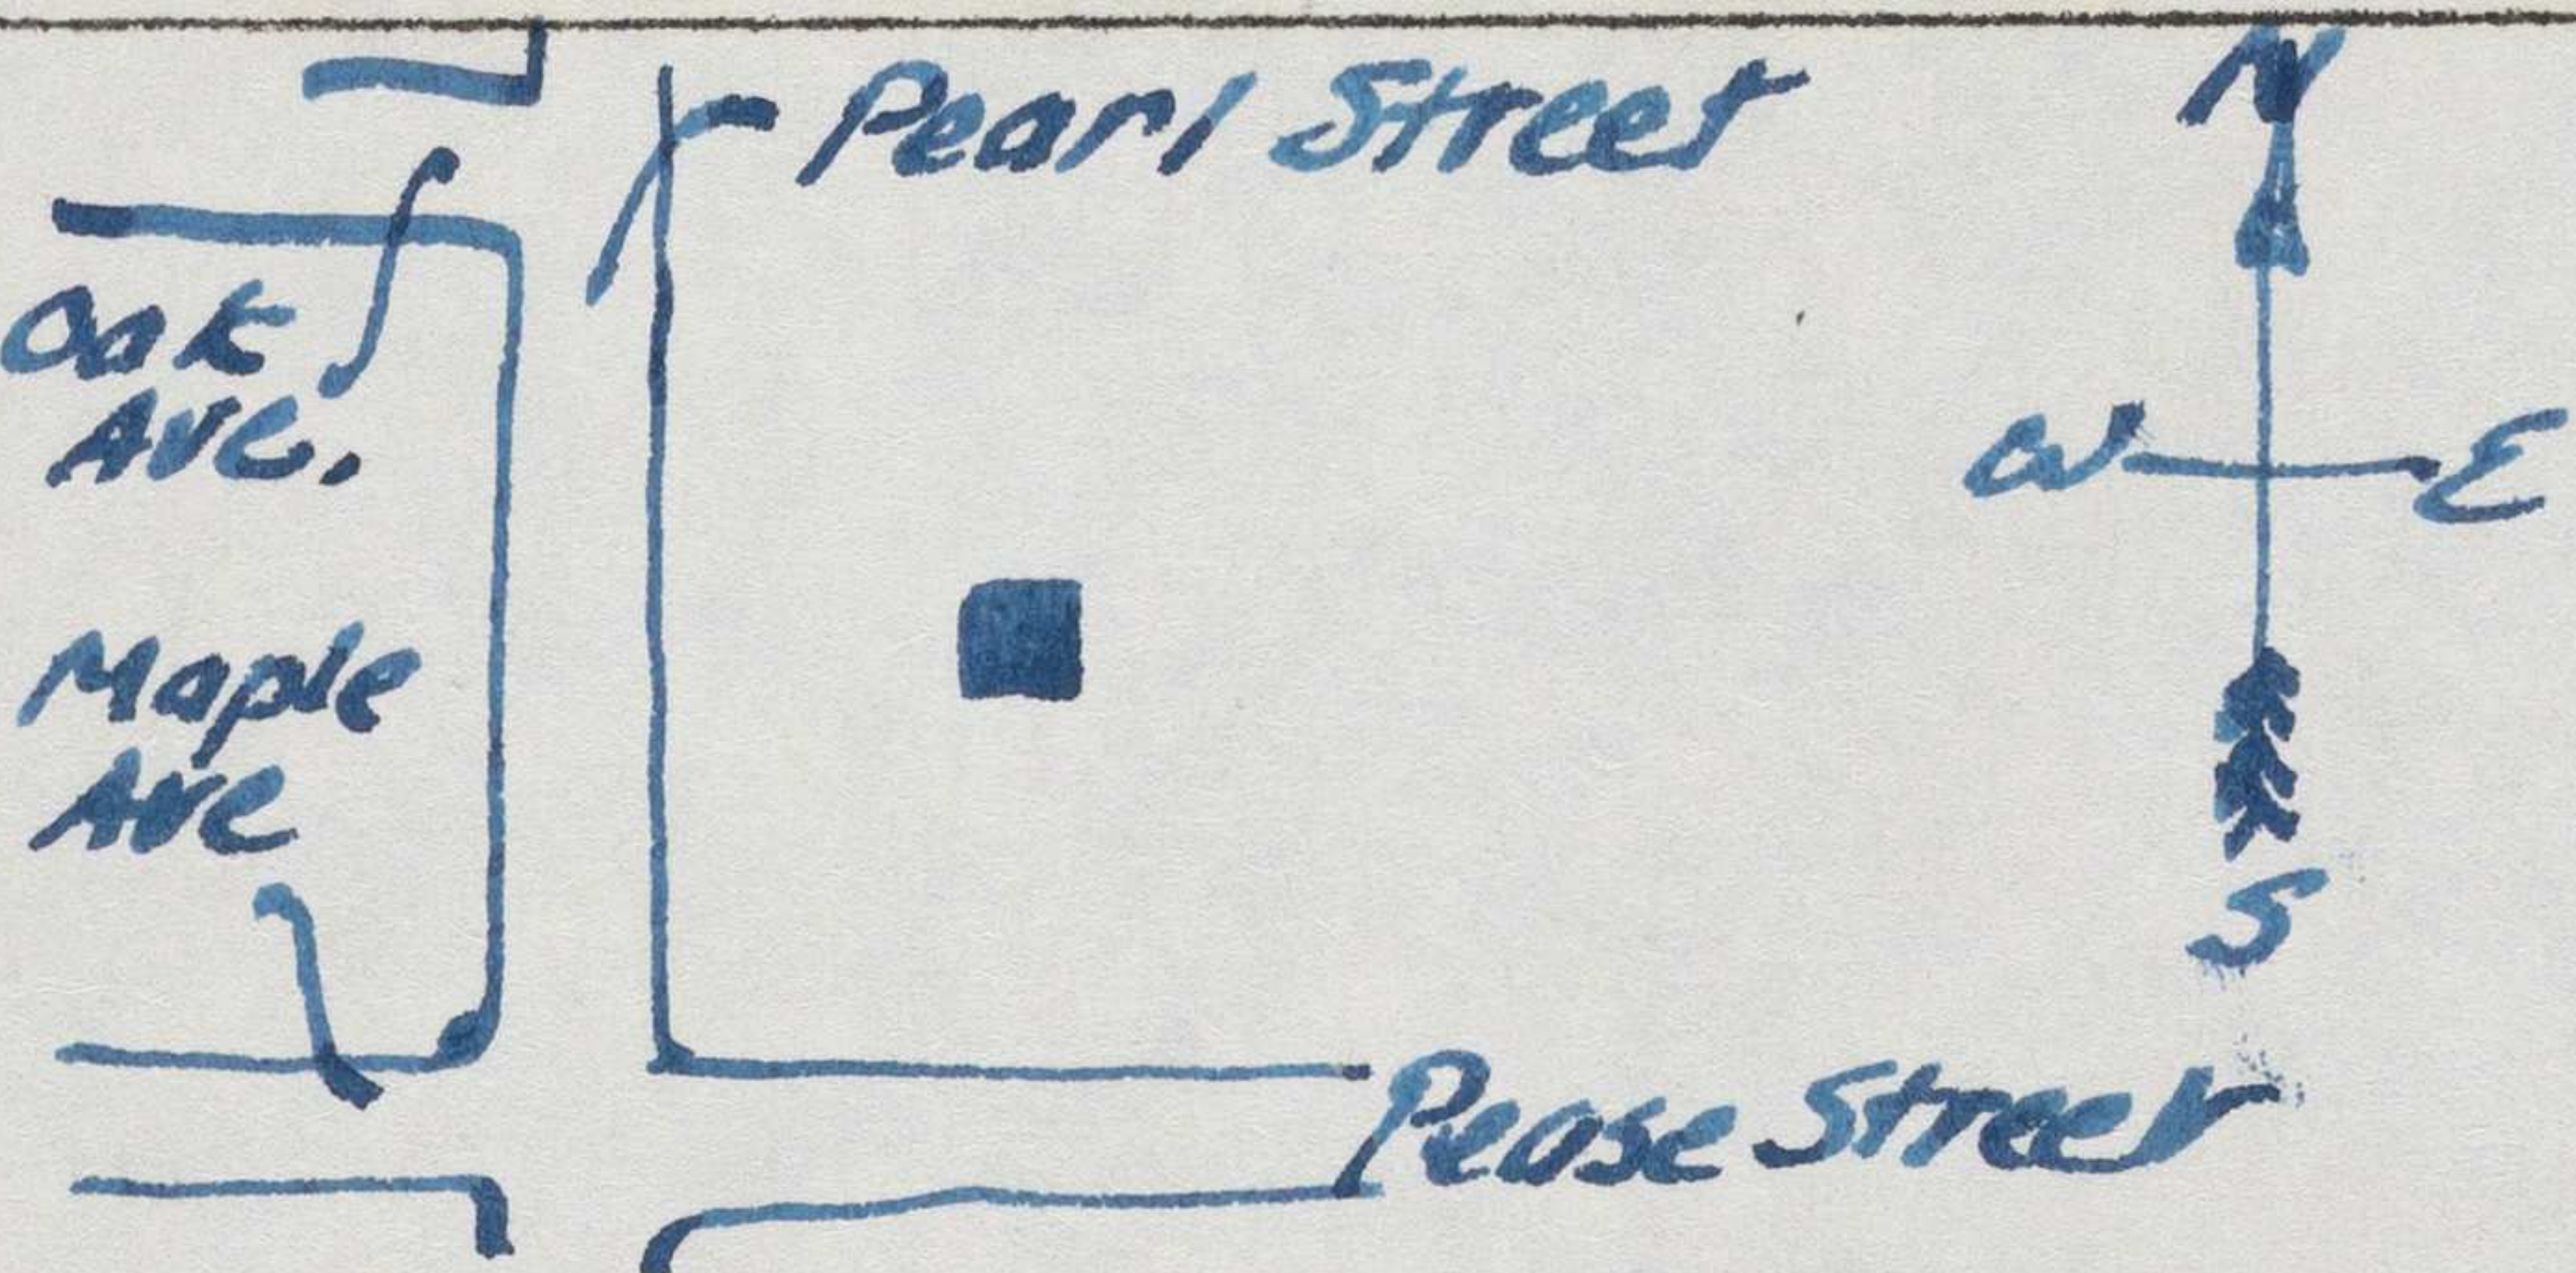
<p>1. STATE <i>ct</i> COUNTY TOWN <i>Enfield</i> VICINITY STREET NO. <i>121 Pearl Street</i></p> <p>ORIGINAL OWNER? ORIGINAL USE <i>Carrriage House</i> PRESENT OWNER? PRESENT USE <i>Garage</i> WALL CONSTRUCTION <i>shingles</i> NO. OF STORIES <i>2</i></p>		<p style="text-align: center;">HISTORIC AMERICAN BUILDINGS SURVEY INVENTORY</p> <p>2. NAME</p> <p>DATE OR PERIOD <i>1880's</i> STYLE <i>Electic</i> ARCHITECT BUILDER</p> <p>3. FOR LIBRARY OF CONGRESS USE</p>	
<p>4. NOTABLE FEATURES, HISTORICAL SIGNIFICANCE AND DESCRIPTION OPEN TO PUBLIC <i>No</i></p> <p style="font-family: cursive;">This is fanciful 19th century building is a pure delight. Above the two barn doors and surrounding the hay loft doors on the 2nd story are is a segmental pediment with other arched wood members, one decorated with fan shaped clapboarding the others in shingle patterns. The building actually has a gambrel roof also of shingles and topped with a cupola with an onion shaped roof and four glass panels to a side.</p>

<p>5. PHYSICAL CONDITION OF STRUCTURE Endangered <i>No</i> Interior <i>fair</i> Exterior <i>good</i></p>			
<p>6. LOCATION MAP (Plan Optional)</p>

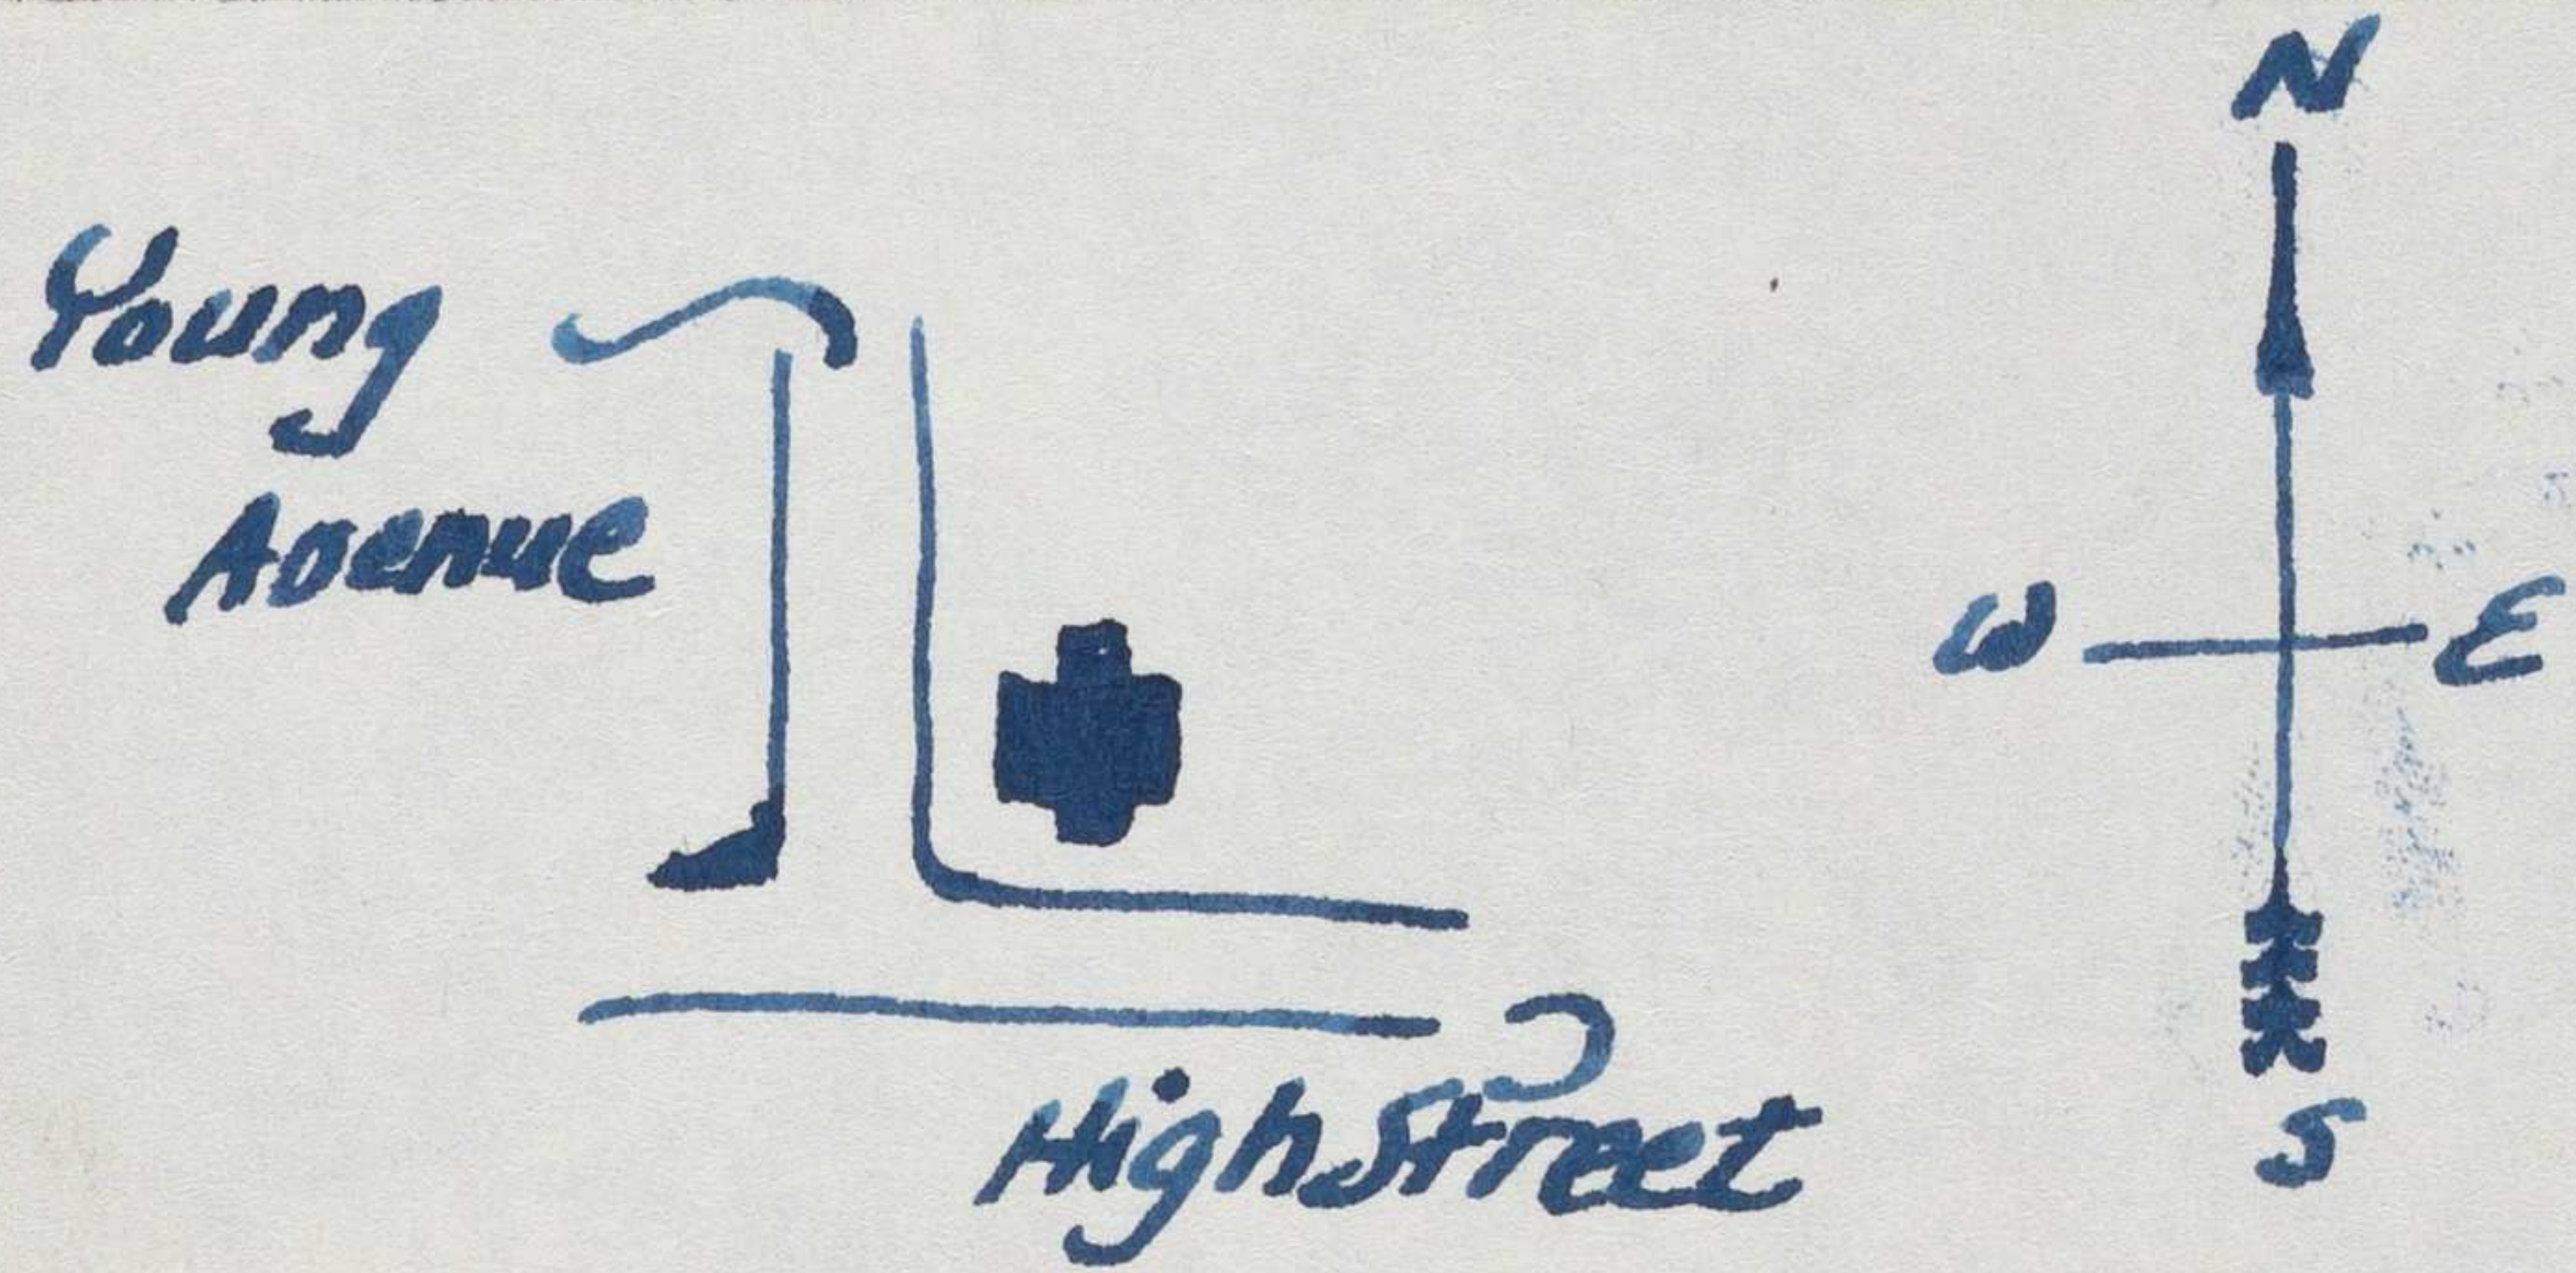
<p>7. PHOTOGRAPH <i>Enf 139</i></p>
<p>8. PUBLISHED SOURCES (Author, Title, Pages) INTERVIEWS, RECORDS, PHOTOS, ETC.</p>	<p>9. NAME, ADDRESS AND TITLE OF RECORDER</p> <p><i>Elric J. Endersby</i> <i>Director</i></p> <p>DATE OF RECORD <i>7/19/67</i></p>

<p>1. STATE <i>Ct</i> COUNTY TOWN <i>Enfield</i> VICINITY STREET NO. <i>131-133 High Street</i></p> <p>ORIGINAL OWNER ? ORIGINAL USE <i>Residence</i> PRESENT OWNER ? PRESENT USE <i>Residence</i> WALL CONSTRUCTION <i>clapboard</i> NO. OF STORIES <i>2 1/2</i></p>	<p>HISTORIC AMERICAN BUILDINGS SURVEY INVENTORY</p> <p>2. NAME</p> <p>DATE OR PERIOD <i>1850?</i> STYLE <i>Late Greek Revival</i> ARCHITECT BUILDER</p> <p>3. FOR LIBRARY OF CONGRESS USE</p>
<p>4. NOTABLE FEATURES, HISTORICAL SIGNIFICANCE AND DESCRIPTION</p> <p style="text-align: right;">OPEN TO PUBLIC <i>No</i></p> <p><i>This cross shaped house is 3 sets of 2 bays, the side portions being recessed behind scroll-work porches. Built on a brick foundation this too family dwelling has many of the features by which its period is known: a shallow pitched roof, plain boarded pediments, heavy entablature and paneled pilasters. The half windows are louvered and placed in the entablature. The rest of the windows are now 2 1/2. Chimneys occur at the middle and sides.</i></p> <p>5. PHYSICAL CONDITION OF STRUCTURE Endangered <i>No</i> Interior <i>fair?</i> Exterior <i>good</i></p>

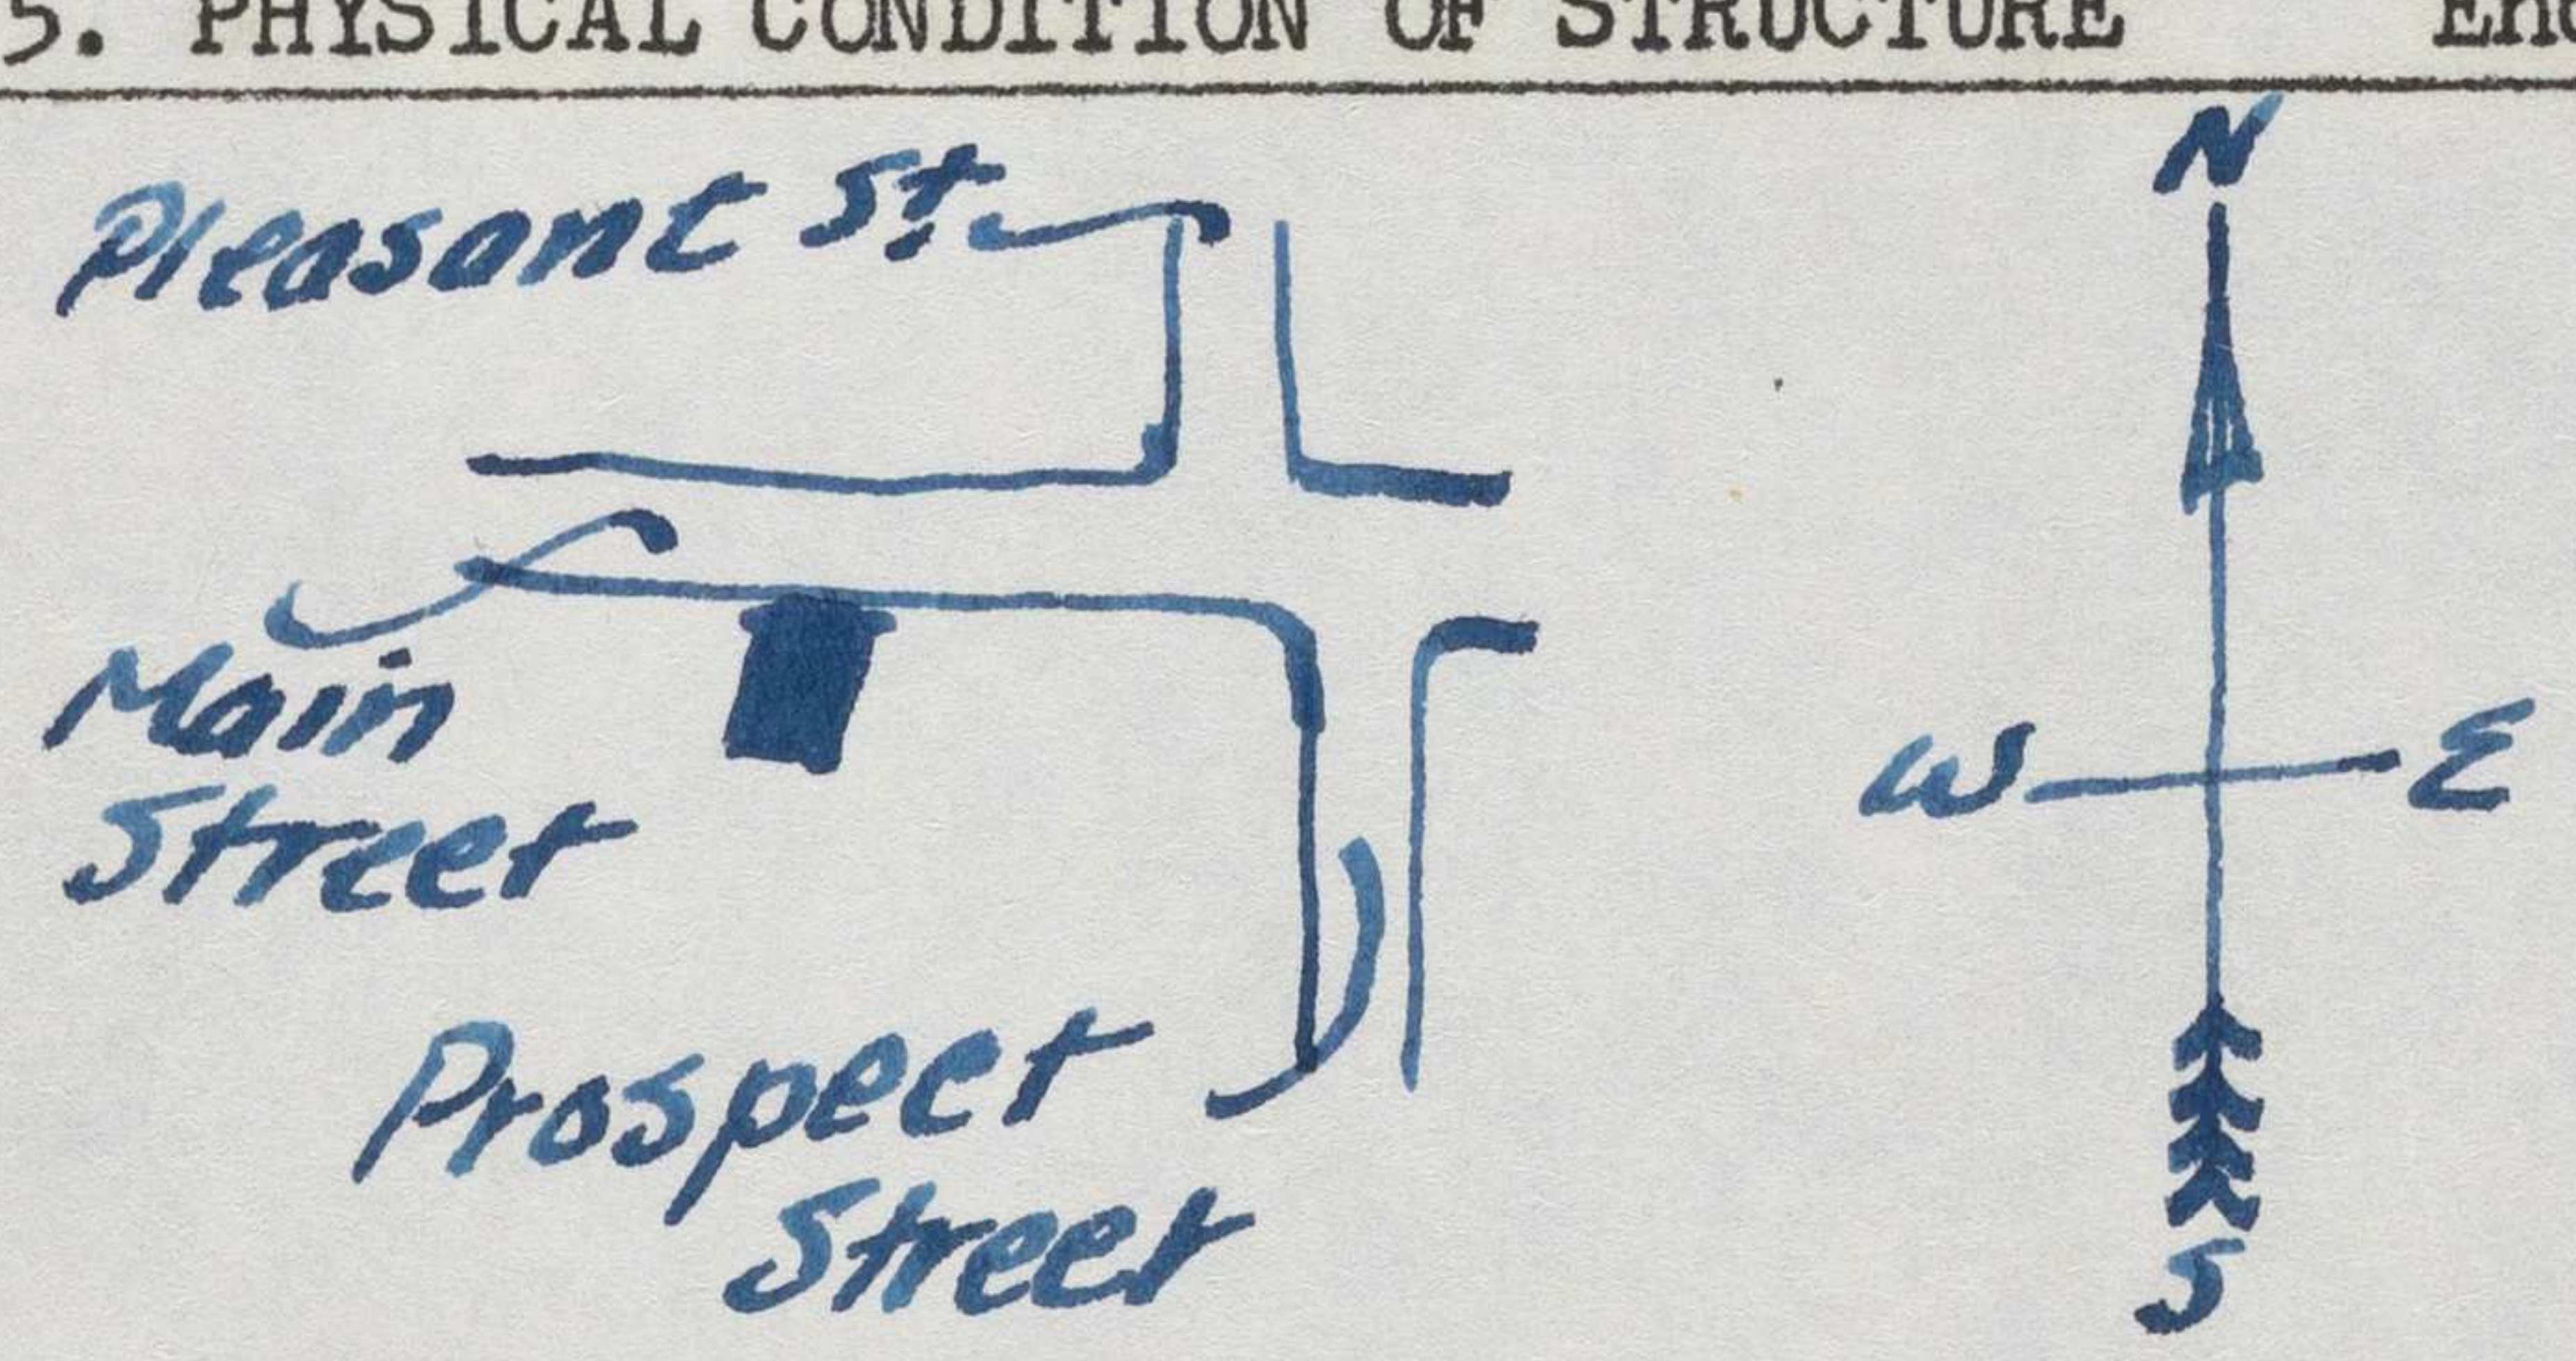
7. PHOTOGRAPH <i>Enf 140</i>

4. NOTABLE FEATURES, HISTORICAL SIGNIFICANCE AND DESCRIPTION <div style="float: right;">OPEN TO PUBLIC <i>Yes</i></div> <p><i>This is a rather interesting 19th century commercial buildings. It is in 3 bays and built of brick. The 1st floor, built on a brownstone foundation, is ornamented with cast iron collonettes with corinthean capitals. The upper windows are 4/2. The nicest feature of this facade are the several courses of black brick and brownstone which form rather charming decoration.</i></p>

5. PHYSICAL CONDITION OF STRUCTURE <div style="float: right;">Endangered ? Interior <i>poor?</i> Exterior <i>fair</i></div>

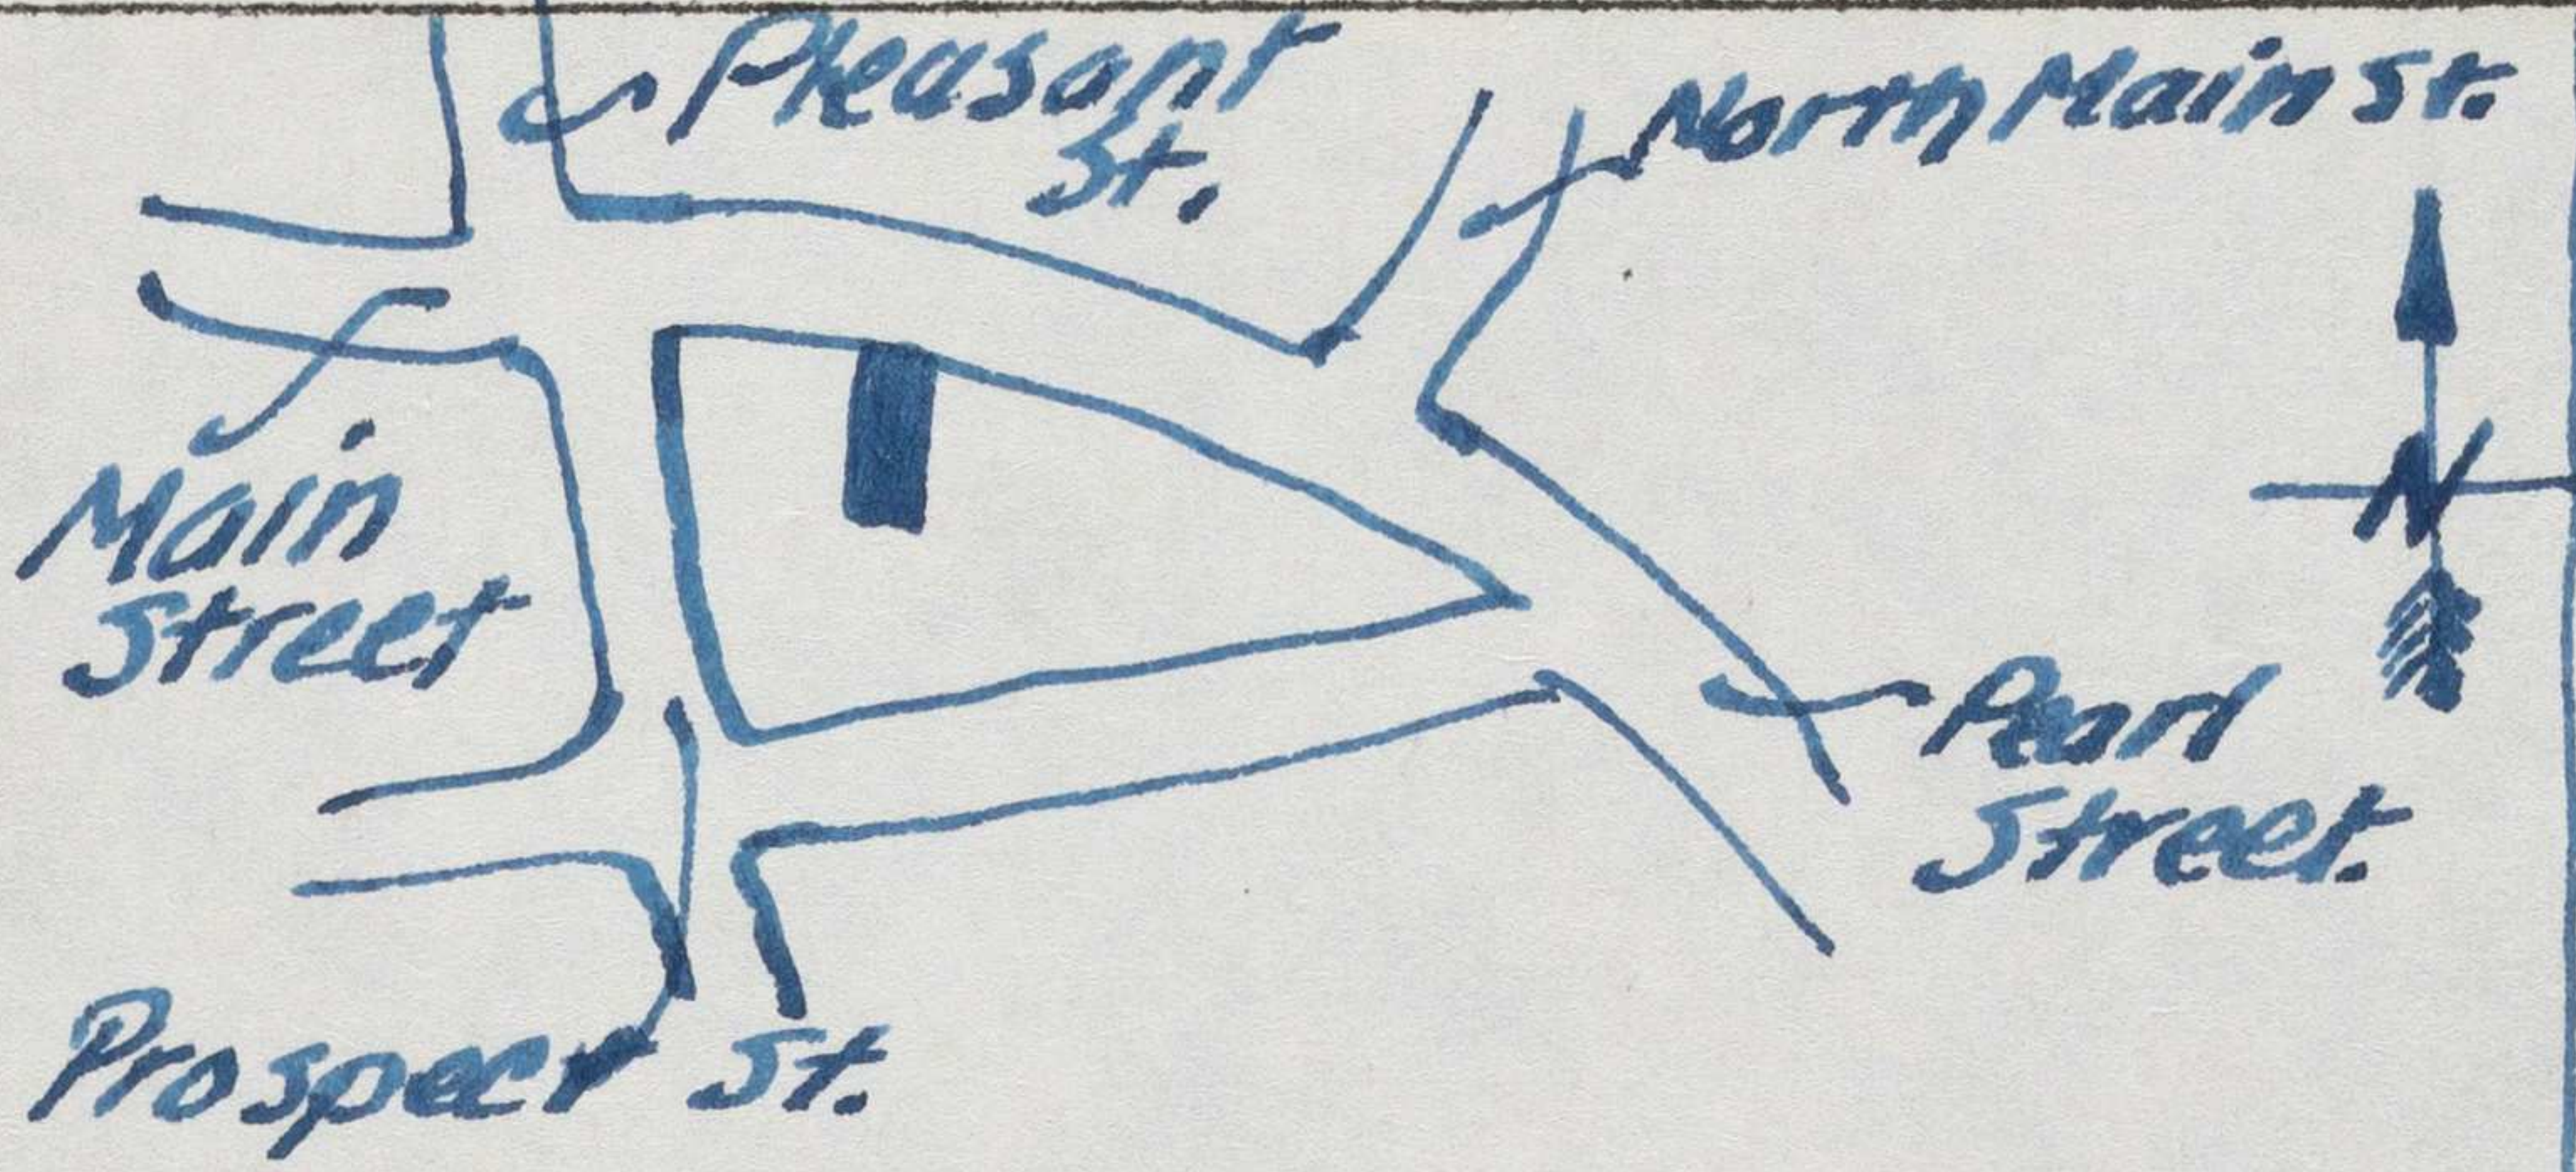
<p>7. PHOTOGRAPH <i>Enf 142</i></p>
<p>6. LOCATION MAP (Plan Optional)</p> <p>8. PUBLISHED SOURCES (Author, Title, Pages) INTERVIEWS, RECORDS, PHOTOS, ETC.</p>	<p>9. NAME, ADDRESS AND TITLE OF RECORDER</p> <p><i>Elric J. Endersby</i> <i>Diego Dudon</i></p> <p>DATE OF RECORD <i>7/19/67</i></p>

<p>1. STATE <i>CT</i> COUNTY TOWN <i>Enfield</i> VICINITY STREET NO. <i>Main Street</i></p> <p>ORIGINAL OWNER ? ORIGINAL USE <i>Shop</i> PRESENT OWNER ? PRESENT USE <i>Shop</i> WALL CONSTRUCTION <i>brick</i> NO. OF STORIES <i>3</i></p>	<p>HISTORIC AMERICAN BUILDINGS SURVEY INVENTORY</p> <p>2. NAME</p> <p>DATE OR PERIOD <i>1870's</i> STYLE <i>Eclectic</i> ARCHITECT BUILDER</p> <p>3. FOR LIBRARY OF CONGRESS USE</p>
<p>4. NOTABLE FEATURES, HISTORICAL SIGNIFICANCE AND DESCRIPTION</p> <p style="text-align: right;">OPEN TO PUBLIC <i>Yes.</i></p> <p><i>This four bay 19th century store front building is built of brick. The 1st floor is ornamented with cast-iron columns with stylized Corinthian capitals. A brown-stone coarse caps this level. The upper floors have 6 windows ornamented with carved brownstone lintels and sills. There is an entablature with brackets and panels and a flat roof.</i></p>

<p>5. PHYSICAL CONDITION OF STRUCTURE Endangered ? Interior <i>poor?</i> Exterior <i>poor</i></p>
